HALF CELL POTENTIALS AND THE CORROSION OF STEEL IN CONCRETE

INTERIM REPORT

CA-HY-MR-5116-7-72-42

Prepared in Cooperation with the U.S. Department of Transportation, Federal Highway Administration November, 1972

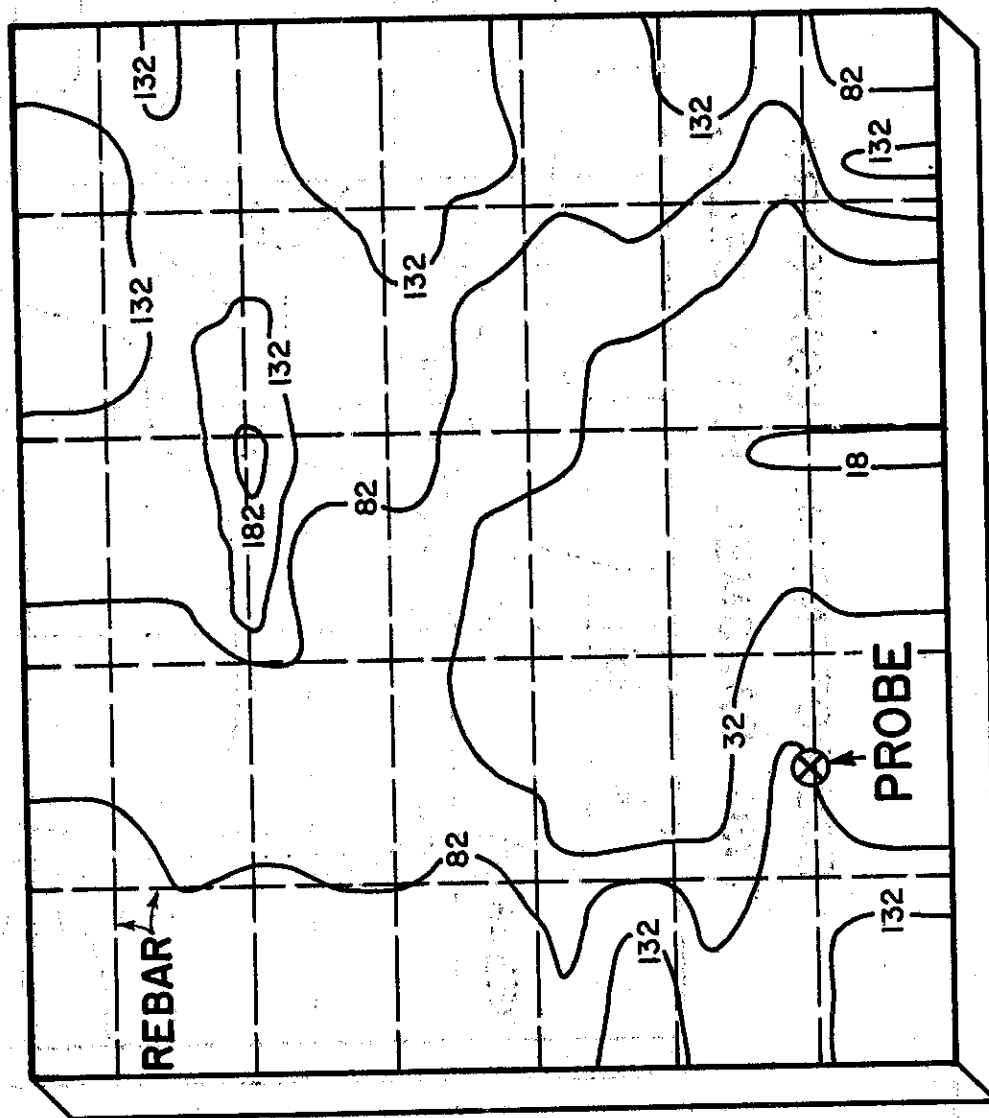
The contours obtained on Figure 9 were obtained from measurements made when one terminal of the voltmeter was connected or "grounded" to the small electrically insulated probe embedded in the slab. The equipotential contours were then drawn using this probe as a reference for the measurements. It will be noted that again there is a great similarity between the equipotential contours obtained by the three methods of "grounding" as shown on Figures 7, 8 and 9.

EQUIPOTENTIAL CONTOURS GROUND TO ISOLATED PROBE

One electrically isolated reinforcing bar is located in the top mat. The location of this one bar not touching the other steel in the mat is noted on Figure 8, by the word "ground". Also included in this test slab, is a 1/4-inch round by approximately 2-inch long steel probe that is embedded into the concrete with 4-inches of concrete cover. This steel probe has a wire connected to it that is brought out through the concrete to the surface to facilitate electrical measurements. The location of this probe is shown on Figure 9. It also is not connected electrically to the other imbedded steel.

Figures 7, 8, 9 and 10 are equipotential contour maps for the simulated bridge deck obtained by using the four different methods of measurements described.

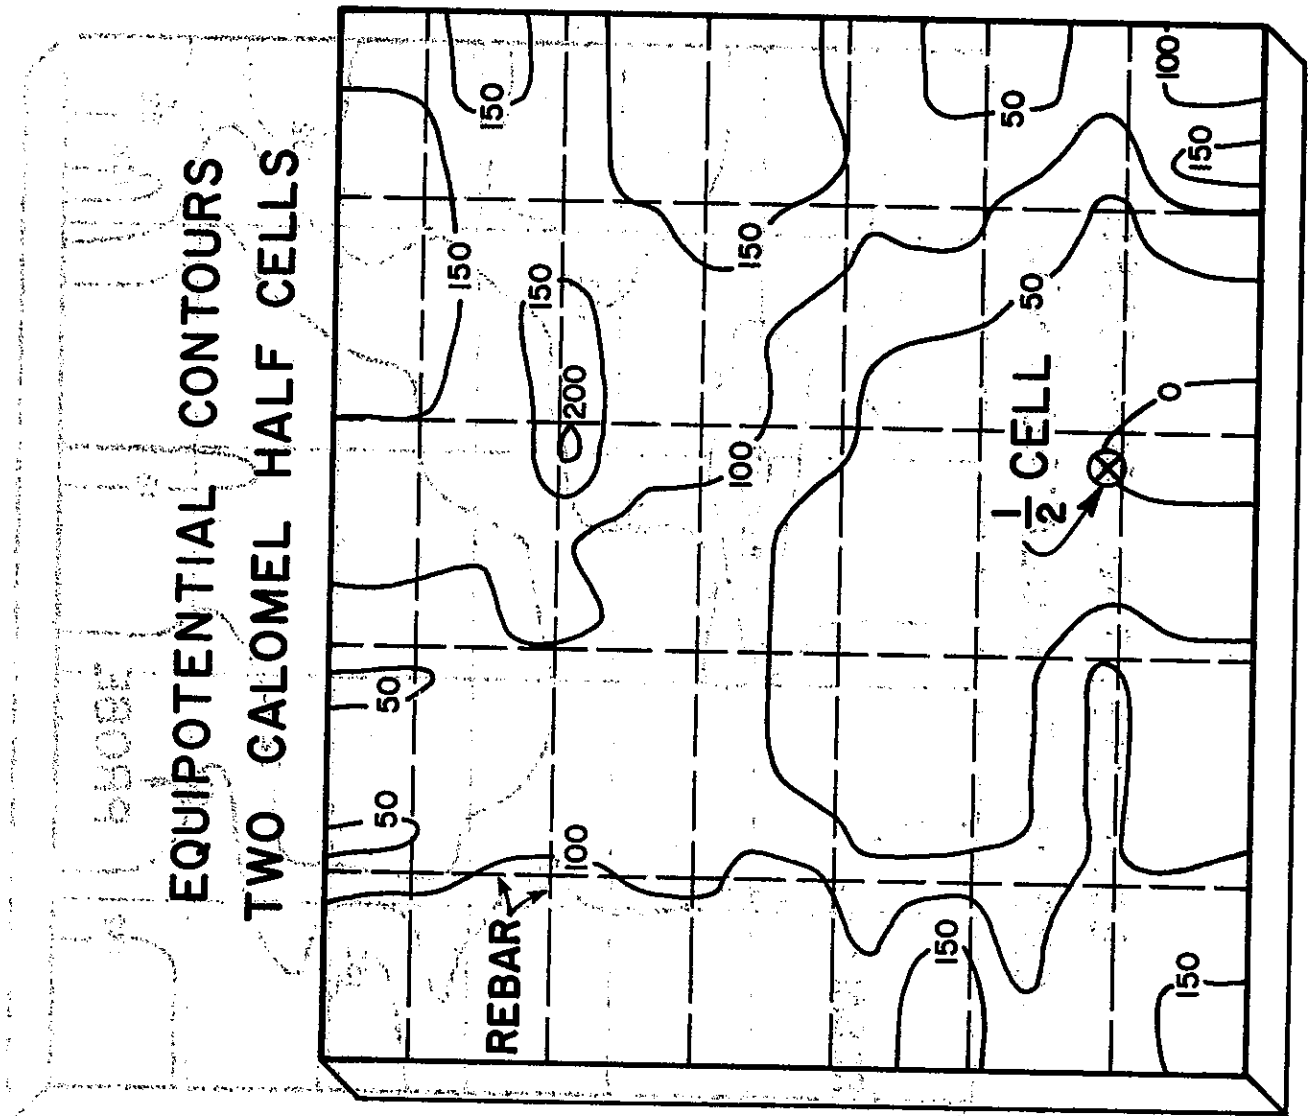
In order to clearly demonstrate the feasibility of obtaining potential measurements without an electrical connection to the steel two saturated calomel half-cells appropriately connected were used to obtain electrical potential measurements. If there were no corrosion caused current flow in the concrete, the measured voltage between these two half-cells would always be essentially zero irrespective of where either half cell was placed on the concrete. The location of the stationary half-cell is shown by the arrow on Figure 10. This half-cell was left in place and never moved during the entire period of the measurements. The other half-cell was moved about to the six inch grid locations. The measurements were then used to draw the contours on Figure 10. As will be noted the contours are similar on Figures 7, 8, and 9. Although the contours are similar the potential values are not. Therefore, it is obvious that care must be exercised in making electrical connections to determine the true value of the electrical potential of the steel. This is particularly true if the measurements are to be used as an indicator of the presence of active or passive corrosion conditions.

The slab surface was marked off at 6-inch intervals longitudinally and transversely. On this grid pattern of 6-inches, center to center, potential measurements were made using a high impedance voltmeter. One electrical connection was made to the saturated calomel cell electrode which was touched to the surface of the concrete at the grid intersections. The other electrical connection to the voltmeter was made in four different ways which were: (1) The potential measurements were referenced (ground) to all of the reinforcing steel (Figure 7); (2) The potential measurements were referenced (ground) to a single, long, but electrically insulated reinforcing bar (Figure 8); (3) The potential measurements were referenced (ground) to an electrically isolated steel probe that is embedded four inches down in the concrete (Figure 9); and (4) The potential measurements were referenced or grounded to a saturated calomel half-cell which was left in place on top of the slab (Figure 10).
